Deterioration rates of wooden dam during natural weathering

Tokyo University of Agriculture and Technology

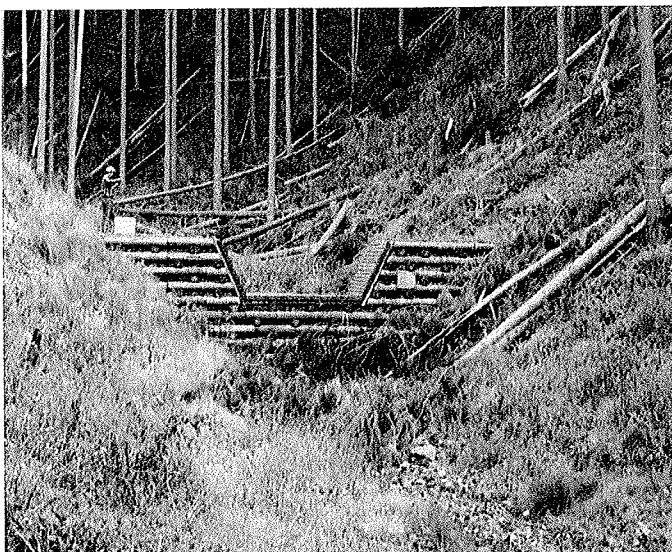
Photo.1 Wooden dam built in field

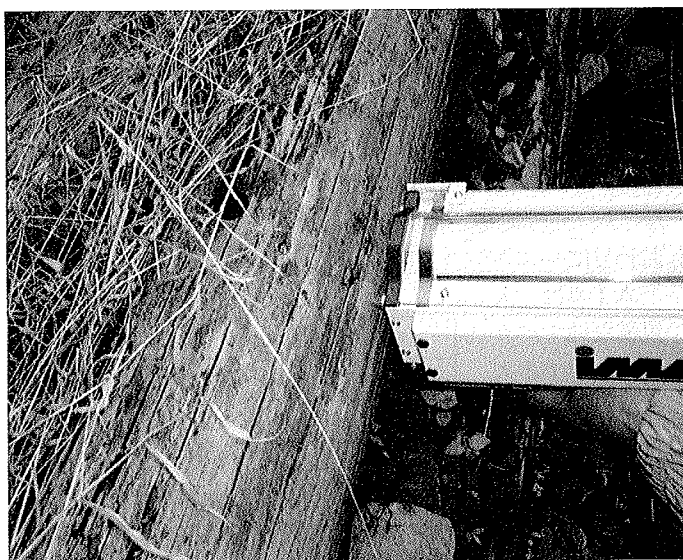
Photo.2 Sampling at the Oe dam

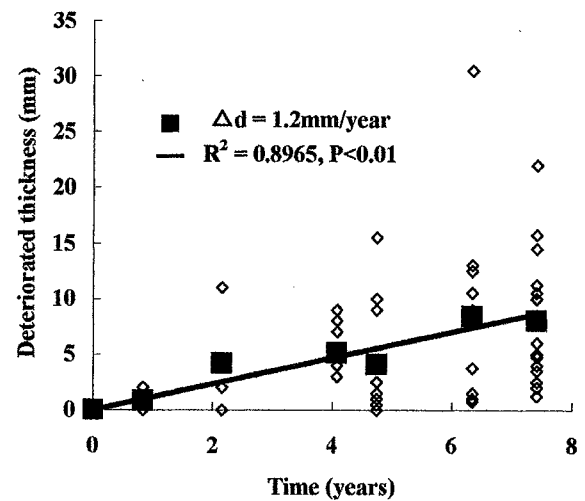
The average deterioration rates of seven wooden dams were calculated from the distributions of deteriorated thicknesses and shown in the Table 1. The graphs of deterioration rates of the whole dam, dam wing and dam body in the Oe dam, were shown in the Figure.1 and Figure.2. Besides that, the difference of deterioration rates between Sugi and Hinoki in the Kuta dam was described in the Figure.3. The deterioration rate of Sugi in the Kuta dam is similar to that of Hinoki and equals 1.6mm/year. It was confirmed that the deterioration rate of the whole dam is different from

Fig.1 Deterioration rate of the whole dam in the Oe dam

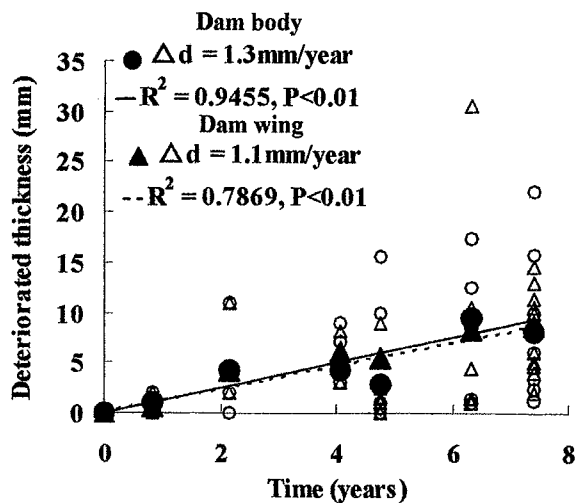
each other. In addition, there was also the difference in the deterioration rates between dam wing and dam body. This difference probably originated from the variation in the weather condition. We found that the water level at the overflow depth of dam contributed to this difference. Moreover, it is necessary to examine the influence of humidity and temperature at the dam site on the deterioration rate. Therefore, in the next research, we will consider the influence of weather factors on the deterioration rate of wooden dams.

Fig.2 Deterioration rate of dam wing and dam body in Oe dam

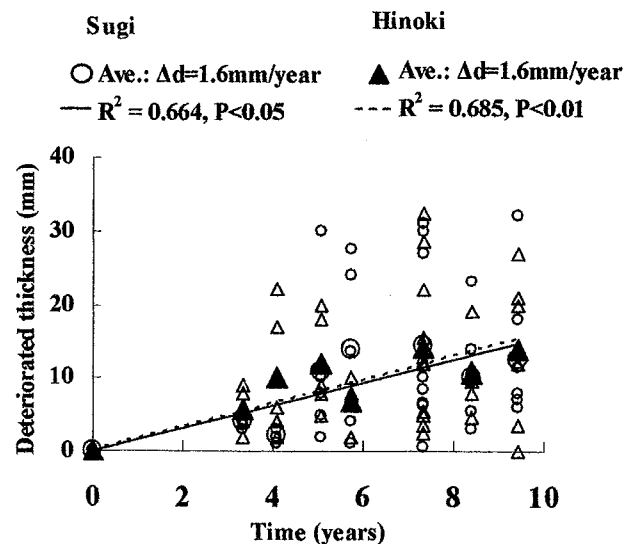
Fig.3 Deterioration rate of Sugi and Hinoki in the Kuta dam
