## Study on bank erosion processes with cohesive and non-cohesive material

○Puji HARSANTO (Kyoto Univ.), Hiroshi TAKEBAYASHI (Kyoto Univ.)  
Masaharu Fujita (Kyoto Univ.)

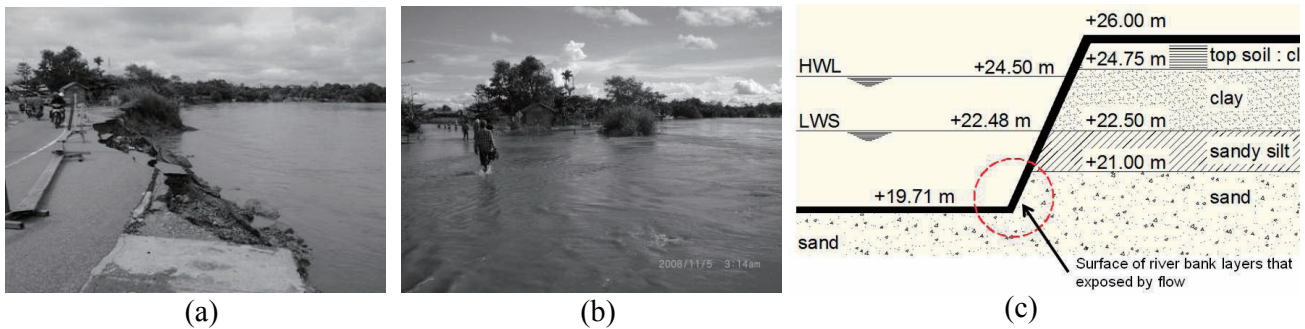
**Fig. 2** Bank failure (a), flooding at Seluwing (b), and stratification of river bank (c)

Fig. 2c shows the stratification layer of river bank. The results from the soil test show that cohesive soil layer (clay) is above of +23.25 m, between elevations +21.00 m to +23.25 m is a transition of soil layer from cohesive soil to non-cohesive (sandy-silt). Below the elevation of +21.00 m is non-cohesive soil presence by sand. The elevation of river bed is +19.71 m and presence by non-cohesive materials. These conditions give high potential of flow to expose the non-cohesive layer of the bank. According to the water level, velocity (numerical simulations) and bank stratifications (field survey) indicate that the processes of bank failure at Seluwing area are as follows:

- Erosion process: The water flow with high velocity causes erosion at the bank toe on the part of non-cohesive soil layer (sand).
- Overhang process: The erosion at the bank toe steepen the bank height that decrease the bank stability and also the erosion of non-cohesive layer develops cantilever of cohesive layers on riverbanks.
- Bank failure process: The susceptibility of the bank to mass failure depends on their geometry, structure, and material properties.
- Temporarily protect, during bank failure and collapse, block of bank material slide or fall toward the toe of the bank, where they remain until they are broken down or entrained by the flow. Failed block may become a temporarily protection at the toe of the bank from erosion.

The results from numerical simulation and soil investigation can describe the processes of river bank. The bank erosion in the Sesayap River causes by the concentration flow velocity due to the presence of the mid-channel bar. That is led to excessive degradation at the bank toe and erosion of the non-cohesive surface bank. The composition of the stratification layers of the bank at Sesayap River has a high potential of bank failure. The basic treatment to prevent the bank erosion can be done by controlling the flow velocity along the bank and or preventing actions to the flow to expose the non-cohesive layer of the bank.
