## Characteristics of Slope Failures and Conditions for Formation of Landslide Dam in Kii Peninsula Caused by Typhoon Talas in 2011

○Hefryan Sukma KHARISMALATRI, Hitomi KIKUCHI, Yoshiharu ISHIKAWA,  
Takashi GOMI, Katsushige SHIRAKI, Taeko WAKAHARA  
(Tokyo University of Agriculture and Technology)

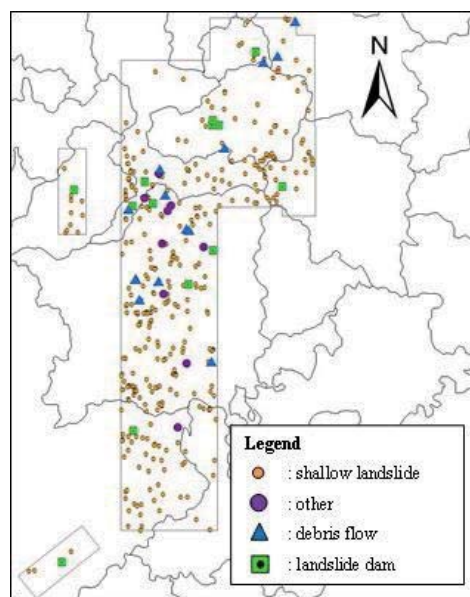
Fig 1. Study area and distribution of landslides at Kii Peninsula

landslides are shallow landslides with mass volume less than 100,000 m<sup>3</sup>. The rest are 13 deep-seated landslides that formed to landslide dams, 12 debris flows, and 9 other deep-seated landslides. The distribution of the landslides is shown in Figure 1.

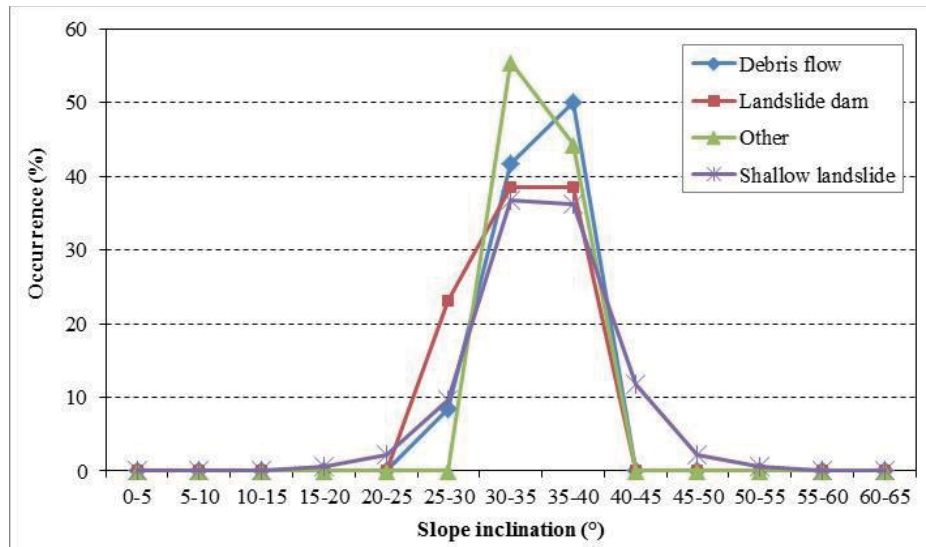
Fig 2. Slope inclination of slope failures

As showed in Figure 2, most of the slope failures occur on 30-40° slopes, either for debris flow, landslide dam, shallow landslide or other type of deep-seated landslide. Most of debris flows occurred at slope with 30-40° inclination, while landslide dam's slope inclinations are distributed between 25-40°. Other types of deep-seated landslides are mostly occurred in 30-40° of slope inclination. Based on the data, there are no deep-seated landslides recorded on slopes more than 40° inclination thus the vulnerability of more

than 40° slope could not be determined. But unstable soil on slopes more than 40° are likely to fall by themselves before they are combined into large soil mass and collapsed into deep-seated landslides.
