Slipping-planes Detection with GPR following the 2015 Kumamoto Earthquake

○ Christopher Gomez ¹, Yoshinori Shinohara ², Haruka Tsunetaka ³, Balazs, Bradak ¹, Norifumi Hotta ⁴

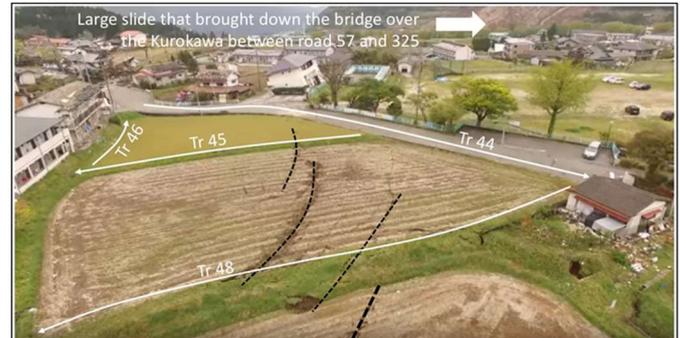
Figure 2 Impacts of the Kumamoto Earthquake on the location, from UAV drone imagery (courtesy of the Geospatial Authority of Japan – www.gsi.go.jp).

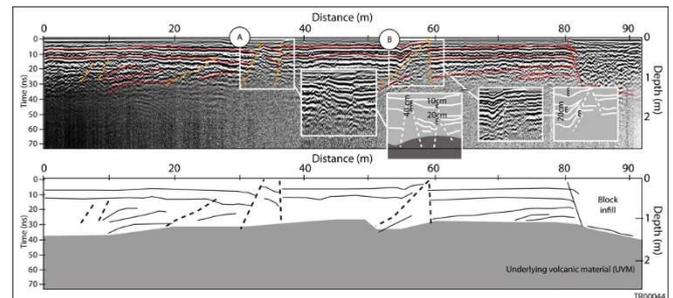
Transect 44 (Fig. 4), oriented along a North-South transect displays a top layer of less than 40-50 cm, that is an originally subhorizontal layer placed for agricultural purposes. Underneath a material consisting of coarse material (a pre-soil or a mixture with the underlying material) extends to a depth of 1 meter to 1.5 meter. The topographic surface does not follow strictly the underlying bedrock and obvious anthropogenic land alteration generated the present surface. The subsurface is also presenting sets of subvertical discontinuities that break the otherwise continuous layers showing the presence of ruptures, or failure lines and planes (human impacts would not offset the left and right side of such break, and it can confidently be associated with the earthquake). Between 50 to 60 m, a wedge shape section seem to have also offset the underlying volcanic material vertically. Along transect 45 (Fig. 5), this time oriented in an East-West

Figure 4. GPR transect 44 with a 500 Mhz antenna on the road. The movement has deformed the soil layers and basculated some of them along rupture planes.

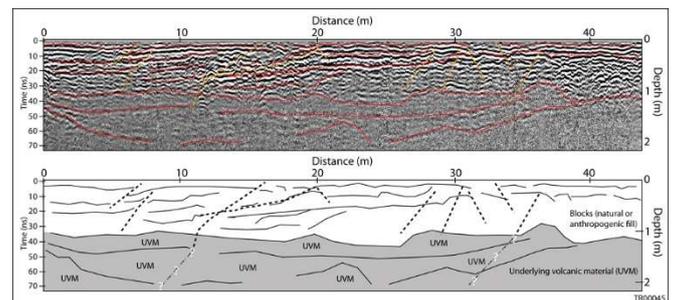
fashion, the subsurface structure is similar, but this time rupture lines are oriented towards the West, or the Kurokawa River. This time the signal was also able to reach through the lower underlying volcanic material, and the rupture lines (planes) could be seen to continue from the subsurface soil down to the underlying material, which also shows the presence of blocks or reflective layers (Fig. 5). In comparison with these two transects, the one along the building (Fig. 6: right of the top radargram) is composed of material that does not show clear breaks, and the material is coarser with multiple block reflections. A U-shape subsurface structure, suggests that either a hole or a buried-channel was also running in this location. Finally, all the transects show complex subsurface layers with a dip towards the East while at the same time displaying local subvertical breaklines with a slight dip towards the West. In transect 45 (Fig. 5), the subsurface breaklines are also continuing underneath the anthropogenic soil into the underlying volcanic material (bedrock?). Using a normalized amplitude imaging method, the phase inversion helps emphasize local variation and changes that can be obstructed by the presence of blocks and other object hyperbolas (Fig. 6). For the transects used in the present study, the phase change confirm that the rupture lines have misaligned the different layers, but also modified characteristics (most probably the density, expressed in differences in soil moisture and gas content). It also shows that the seemingly presence of a hole or a buried channel is most probably a land-fill rather than a natural features and at the contact of this landfill with the natural feature, there is a zone at the end of the transect, which is of different material characteristics (most probably density). The same feature appears in transects 44 and 45, when close to the buildings. One hypothesis is the natural density difference due to the building mass on the subsurface material, another one is the effect of the mass of the building during earthquake acceleration, generating differences in the soil, finally it is also most probable that the landfill underneath the house is different from the one in the cultivated field, and it might be only a man-made feature.

Figure 5. GPR transect 45 across the agriculture terrace. The visible surface rupture are all oriented towards the valley with almost horizontal bedding structures that show higher reflectivity and the creation of potential sliding surfaces.

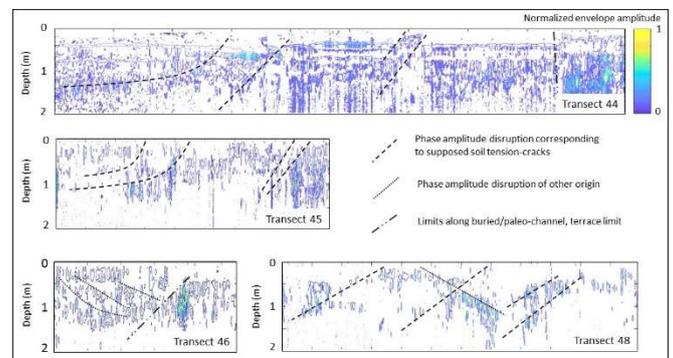
Figure 6. Signal normalized envelope distribution across the 4 transects showing the soil structure's discontinuities and anomalously concentrated amplitude returns.
