## Assessment of Swa Dam Breach Using Empirical Formulas and Satellite Data

Pa Pa Shwe Sin Kyaw, Taro UCHIDA (University of Tsukuba)

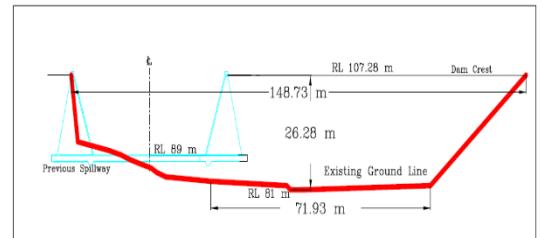
From the topographic data, the maximum cross sectional width of the breach is about 148.73 m, bottom width of breach is about 71.93 m and average breach width is 110.33 m. Height of Breach is about 26.28 m from the dam crest RL- 107.28 m, as shown in Figure 2.

Figure 2. Cross section of breach (Blue before, Red after)

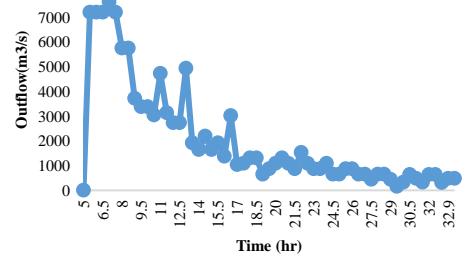
Maximum breach discharge occurred in spillway failure event was calculated which was about  $7218.5 \text{ m}^3/\text{s}$  at 102.68 m water level happened at 5:30 am in the morning using observed water level recorded during the breach and height-volume relationship of the Swa dam as shown in Figure 3.

Figure 3. Calculated Breach outflow
