Sediment Disasters Caused by Typhoon No.14, 2005, in Miyazaki Prefecture

Yoshinobu TANIGUCHI ¹

Typhoon No.14 struck Japan in September, 2005, subjecting large areas to danger for many hours. The maximum hourly rainfall was not so great, but the total rainfall for 72 hours was > 500 mm in areas which suffered considerable damage. The typhoon caused 116 debris flows, 185 slope-collapses, and 30 landslides. Concerning human and building casualties, twenty-seven people were killed in Kagoshima, Miyazaki and Yamaguchi Prefecture, and two people went missing in Oita Prefecture. Additionally, 1,178 houses were completely destroyed and 3,692 houses were partly destroyed in Japan by the typhoon. These damages were due to comparatively heavy rainfall which continued for many hours. Large scale slope-collapses occurred in particular, around Miyazaki Prefecture due to heavy continuous rainfall (862 - 1,321mm).

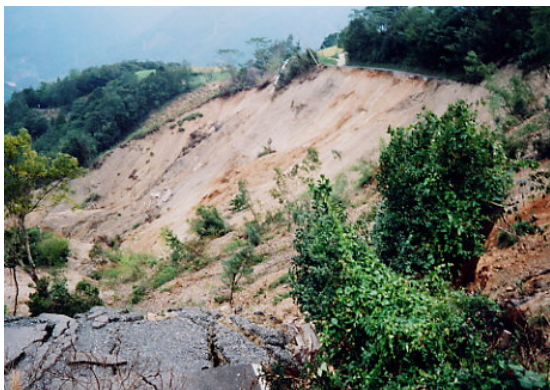
Two large slope-collapses were caused by typhoon No.14 at Koba and Hazuware in Shiiba Village (Photo 1). Investigations by the Higashiusuki Agriculture and Forest Division of Miyazaki Prefecture found that the collapsed area of Koba was encompassed about 5 hectares and in Hazuware about 4.2 hectares. These areas are mainly underlain with sandstone and shale, which are extremely compressed and eroded. Talus accumulation is thick. Depths of these collapsed soil layers were estimated to reach 30 - 40 meters. Many fissures were found out on the earth surface around the scarp of the collapse in Koba. These fissures arose within a zone of 50 - 100 meters from the scarp. Therefore it is feared that this collapse may expand in the near future. The road which was used by school children before the collapse was completely demolished, thus making the safe transit of children to school a major problem for the community. According to one resident, this collapse might have occurred at about 07:30 on September 6th. The resident's neighbors did not notice that the land by their house had collapsed. The collapsed slope is composed of sandstone and shale.

Photo 1 A large slope-collapse at Koba in Shiiba Village.

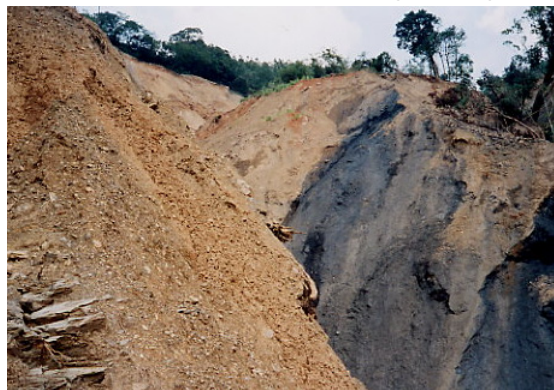
Photo 2 A scene of a large gully in the collapse at Koba.

Excessively eroded mudstone layers were embedded in the soil layers and at some locations spring waters appeared. Some conspicuous gullies which were formed on the slope could be observed below springs. Excessively eroded mudstones are located in both sides of these gullies (Photo 2).

Springs still existed in some places on September 21st, 15 days after the typhoon. Flooding marks by the typhoon were seen in the gully (Photo 2). They were located at a height of about 2 meters above the stream bed. This indicates that a large amount of flooding occurred at the peak of the typhoon. Thus, an upsurge of spring water may have occurred then, as well. Some fissures were also noticed in this area 42 years ago, and a house which had been located there had already been moved to another place. The weathered sandstone, which the slope is comprised of, contains many vertical cracks. Additionally, a road with a hairpin curve located in the middle of the slope may have contributed to this collapse. Cracks in the sandstone layer would allow the deep infiltration of surface water run-off from the road into the soil layer near the hairpin curve during the storm. The collapsed soil mass was completely converted into a debris flow and ran up to a height

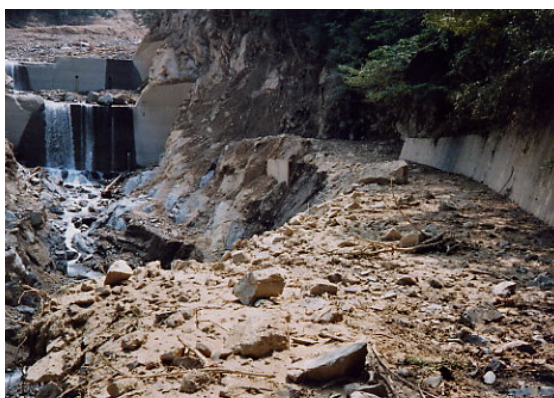
Photo 3 The mark of a debris flow left in the Hazuware Torrent in Shiiba Village.

of 25 meters above the stream bed on the opposite side of the Hazuware Torrent. The debris flow partly destroyed two check dams in the Hazuware Torrent and moved into the Mimikawa River after that. Judging from marks of the debris flow shown in Photo 3, it was about 40 meters wide and 20 meters deep. However, most of the debris flow was caught, reducing its force and radically changing the course of its flow to the left by way of aforementioned check dams. Thus, a house which stood on the right bank of the torrent below the dams was saved from the disaster.

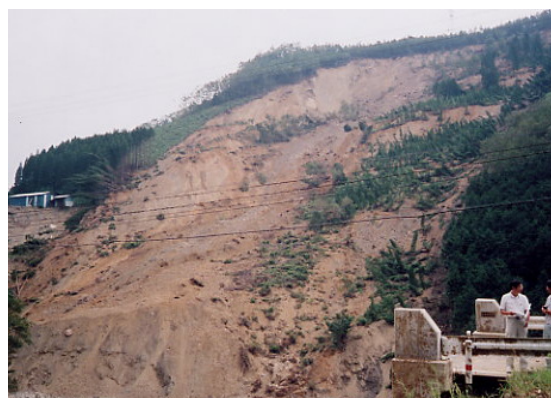
Photo 4 A large slope-collapse at Takenohae in Shiiba Village.

Another debris flow occurred at Takenohae in Shiiba Village. It completely destroyed and washed the 10- m long Nakahata Bridge, indicating that the debris flow had great intensity. The debris flow crashed against the slope on the opposite side of the river, causing a large slope-collapse there (Photo 4).

The high flood point shows that the debris flow might temporarily dam the Mimikawa River. The cross section of the debris flow was 20 meters wide and 7 meters deep. A debris flow also occurred at Yogariuchi in Shiiba Village, and the ground collapsed underneath where a factory stood. Its factory slipped 30 meters down to the bottom of the Yumiki Torrent and it was completely washed away.

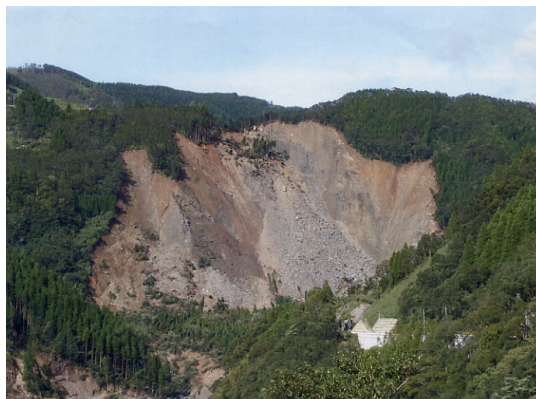
Photo 5 A large slope-collapse at Nonoo in Saigo Village.

A large slope-collapse also occurred at Nonoo in Saigo Village (Photo 5). This collapse may be attributed to the following causes: pore water pressure accretion in the talus accumulation layer and erosion of the foot of the slope (composed of eroded sandstone about 40 meters thick) by the flood water. In fact, the water level in the Mimikawa River was 2 - 3 times as high as in the usual flooding during typhoon No.14. The time of the collapse occurrence was at 21:49 on September 6th. An observation by the National Research Institute for Earth Science and Disaster Prevention which makes seismological observations certified that their seismograph caught an earthquake caused by this collapse at 21:49. Connected to this event, there was the fact that a resident had seen three cracks on the slope at about 16:00 on September 6th.

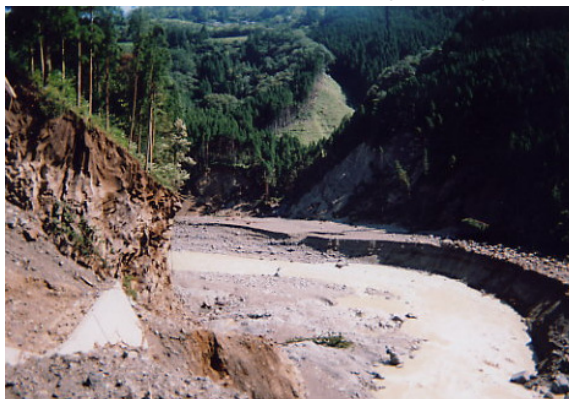
Photo 6 Mark of a landslide dam at Nonoo in Saigo Village.

The river was temporarily blocked by a collapsed soil mass which had formed a landslide dam. As evidenced by the dam, the flooding mark shown in Photo 6 was found at a height of 15 meters above the channel bed. This landslide dam was further evidenced by the fact that a water level gauging of Yamasubaru dam which is located about 6 kilometers downstream from there dropped abruptly after the event. Another large slope-collapse occurred at Shimado close to Nonoo. Some new fissures were found after the collapse, located within an area of several hundred meters from the scarp. The community surrounded by these fissures indicated the possibility of a future collapse.

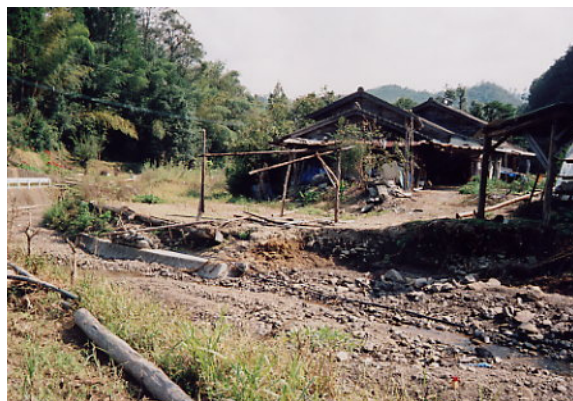
Photo 7 One of houses averted from a debris flow owing to a check dam.

Additionally, many erosion check dams have been constructed to control sediment discharge. Thus, casualties related to sediment disasters have been often prevented owing to these check dams. In fact, the Mataebaru check dam protected residents during typhoon No.14 (Photo 7).

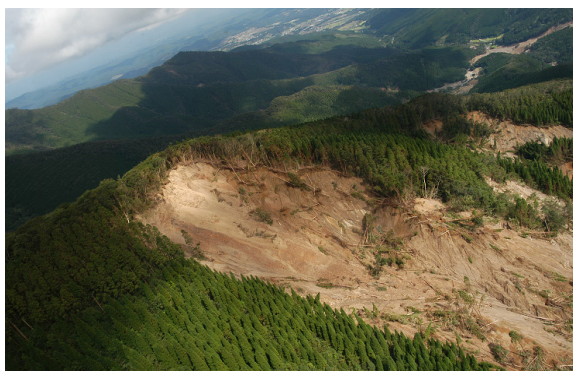
Photo 8 A large slope-collapse in the basin of the Byutano River at Mt. Wanitsuka.

A resident living beside the Byutano River (Fig. 6) mentioned that stones were rolling down through the river around 07:00, but this sound stopped at about 08:30 and a stoppage of electric current happened at about 09:00. He saw trees swinging violently along the river at that time. It can be assumed that the river must have been blocked by the collapsed soil masses at about 09:00 and the debris flow followed. This scenario is consistent with the peak precipitation during the typhoon. One of large slope-collapses at Mt. Wanitsuka is shown in Photo 8.

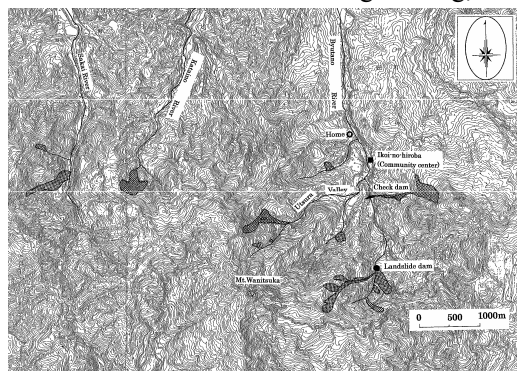
Fig. 6 Sites of large slope-collapses at Mt. Wanitsuka. Each mark(●) shows the sites of these collapses.

Large slope-collapses shown in Fig. 6 occurred at Mt. Wanitsuka in Tano Town, Miyazaki Prefecture on September 6th, 2005. Mt. Wanitsuka consists of sandstone and shale. These strata originated on the bottom of the Sea of Hyuga in the Tertiary period and they gradually thrust upwards to form land (Miyazaki Prefecture, 1978).

were caused by typhoon No.14 on September 6th, 2005, and large debris flows followed. The sites of these large collapses are shown in Fig. 6. Another large collapse occurred along the south flank of Mt. Wanitsuka in the Hiroto River basin.

An extremely large slope-collapse occurred in the basin of the Byutano River and a landslide dam was formed by this collapse (Fig. 6). Field surveys by the Miyazaki Forest Management Office indicate that the height of the landslide dam was 18 meters, the length of its slope from the crest to the foot was 60 meters, and its slope gradient was 17 degrees. Tests on the soil samples collected from the dam 5 days after the occurrence of the collapse indicated that soil hardness was 0.85 kgf/cm², void ratio of it was 63.5%, and the coefficient of its permeability was 6.9×10^{-3} cm/s. Sediment deposits in the dam were very watery. A potential crisis of flood levee failure of the dam was averted because a channel for drainage was excavated along the left side. Sediment in the stream bed of the Byutano River was also rather fluid 22 days after the debris flow occurrence. The percentage of water content was 17.5% on September 28th, indicating that the sediment deposit was still in a dangerous state for the occurrence of a debris flow. A grate amount of wood transported by the debris flow was deposited into the Byutano River just after the debris flow occurrence, but was soon removed.

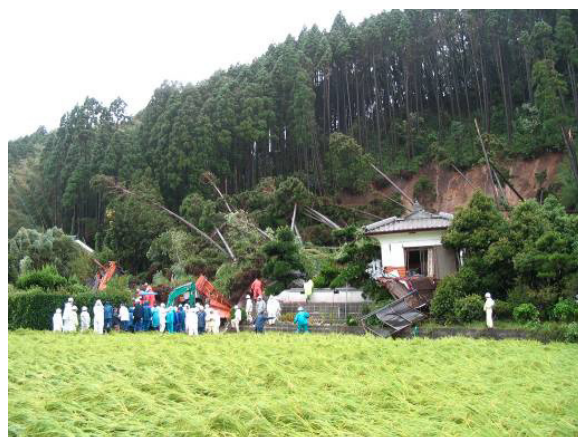
The slope-collapse happened at Nagata in Mimata Town at about 15:00 on September 6th, 2005, 15 hours after the peak of rainfall (Photo 9). This slope-collapse was 15 meters high and 30 meters wide in a shirasu layer (volcanic ash) with a slope gradient of 35 - 40 degrees. Rainfall intensity of 20 - 27 mm/h continued for 5 hours from 07:00 to 11:00. Likely this sequence of rainfall must have caused the slope failure, because a large amount of water seeped into the slope, causing the weight of the soil layer to increase substantially. A retaining wall for collapse prevention had already been constructed at the foot of the slope behind the damaged house. However, the collapsed soil mass ran over the retaining wall and destroyed the home. Two people were killed by this slope-collapse.

Photo 9 A slope-collapse at Nagata, Mimata Town.

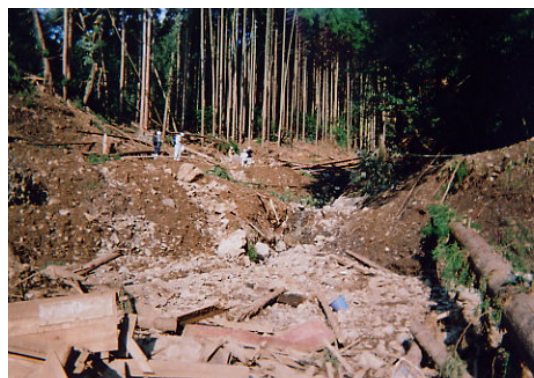
Two incidents of casualties took place in Takachiho Town. One person was killed by a slope-collapse at Hatanaka and 4 people were killed by a debris flow at Torokuminami. The former was a talus slope-collapse which had previously been used as farmland. Several rills etched on the earth surface were found along the right side of the relin-quished farmland, indicating a lot of water had seeped into the talus during the heavy rain. Another slope-collapse occurred at the head of the small stream at Torokuminami (Photo 10). This was the largest of collapses related to casualties by typhoon No.14 in Miyazaki Prefecture.

This slope was composed of volcanic ash and talus accumulation, and has a gradient of 30 - 35 degrees. The soil hardness was 3 - 4 kgf/cm² and 0.5 - 0.7 kgf/cm² for volcanic ash and talus, respectively.

A great amount of water must have percolated into the talus accumulation layer which was located above an aquiclude of the volcanic ash layer during heavy rainfall. This stream is perennial, and flood discharge during the heavy rainfall would be fed in great amount to the collapsed soil mass. Thus, the soil mass was converted into a debris flow while running through the channel and then struck a house located about 300 meters downstream from the head of the stream. Nevertheless, the entire soil mass did not liquefy, because a portion was still plasticized.

Photo 10 A debris flow at Torokuminami, Takachiho Town.

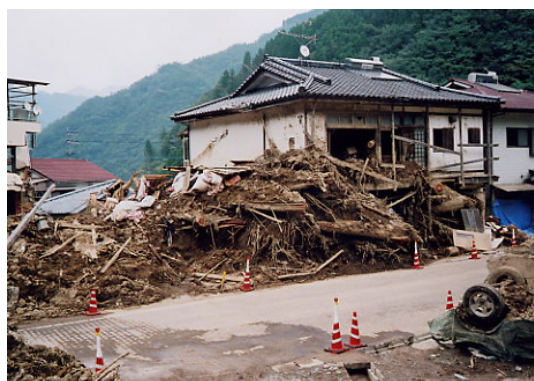
Three people were killed at Kamishiiba in Shiiba Village by a debris flow which rose up at the foot of a retaining wall along a prefectural road (Photo 11). The slope consists of talus and eroded sandstone. It is assumed that talus accumulation must flow along the boundary between the underlying sandstone layers. Some instability was apparent along this road. There was a crack along the left shoulder of the road, and the guardrail had already subsided about 30 centimeters prior to the collapse. It is believed that a lot of water must have seeped into the talus accumulation layer through this crack during heavy rainfall. This was evidenced by the appearance of spring water on the slope. However, residents of this area believed that it was absolutely safe, because no disasters had occurred in the past 800 years. However, a debris flow occurred in 2004 in a neighboring stream which

Photo 11 A debris flow at Kamishiiba, Shiiba Village.
