AN ANALYTICAL APPROACH ON LAS COLINAS EARTHQUAKE-INDUCED LANDSLIDE IN EL SALVADOR

Takashi Okimura Professor, Research Center for Urban Safety and Security, Kobe University
 Nobuyuki Torii Research Associate, Research Center for Urban Safety and Security, Kobe University
 OJorge E. Villamarin Graduate Student, Kobe University

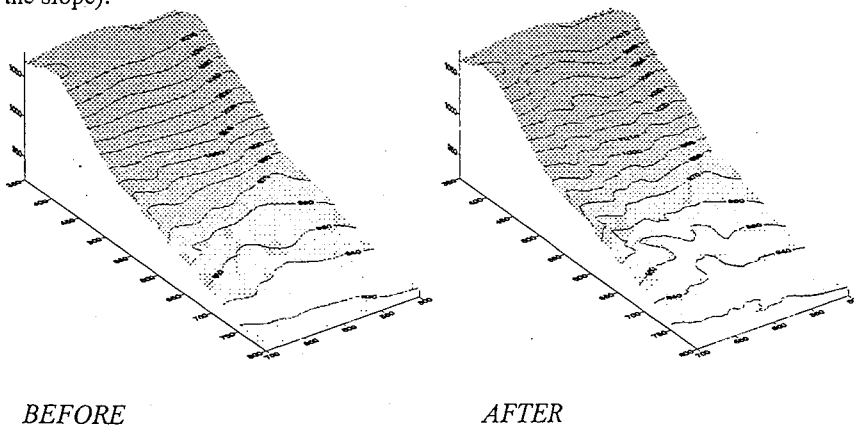
The complete DEM for both situations -before and after- can be seen on figure 1. After obtaining longitudinal and cross sectional profiles based on the DEM for the affected area, and analyzing their properties, critical profiles were identified in X=626 and Y=414. From profile X=626, the area affected by the landslide can be subdivided on four main parts (Fig. 2). The sections described were found by comparing the original topographic features; this is before the earthquake, with those after the same. As contour lines before the earthquake show a similar pattern distribution (almost homogeneous for the steep part of the slope).

Fig. 1 - Block (3D) Diagram for Las Colinas Landslide (Units in Meters)

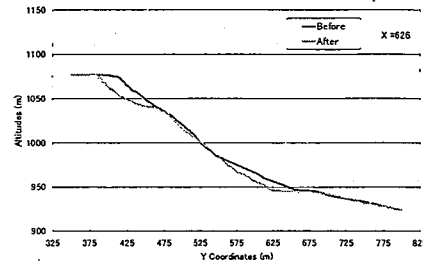
As Y-axis increases, four sections are identified:

Section 1. A first block that can be described as a "hollow". This block not only was observed to slide over a clearly defined rotational slip surface but also somehow expelled or pushed from its center. This phenomenon could be explained by the high N-S over E-W accelerations. The material involved on this first section traveled all along the slope reaching and running into the neighborhood.

Section 2. Between altitudes 1,040 and 985 on the same X=626 profile, a second section is easily recognized. If no noticeable in all the profiles.

Section 3. This section is very different

from the first one described above, while the first could be described as a “hollow” this one is a slice clearly slipped above the already mentioned translational failure surface.

Section 4. The material in this one is deposited above the original ground surface on shallow layers, having run into the neighborhood hundreds of meters. From an analysis of aerial photographs our team concluded that the real distance traveled by the debris flow into the neighborhood from the toe of the slide was **360 mts.**

Fig. 2 Longitudinal Profile X=626
