Emergency response and permanent measures for large landslide dams triggered by the 2004 Mid-Niigata Prefecture Earthquake in Japan

Yoshiki NAGAI¹, Jun MARUYAMA¹, Katsumi YOSHIDA¹, and Takao YAMAKOSHI²

¹ Yuzawa Sabo Office, Hokuriku Regional Development Bureau, Ministry of Land, Infrastructure and Transport, Kandachi 23, Yuzawa Town, Minami-Uonuma gun, Niigata, 949-6102 Japan (yuzawa1@hrr.mlit.go.jp)

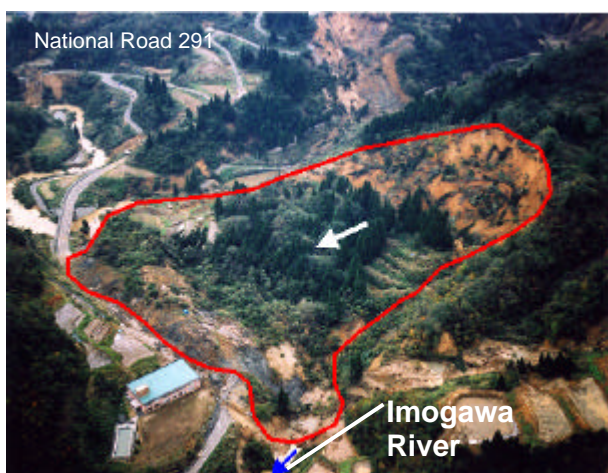
Photo 1 Landslide dam in the Higashi-Takesawa dist.

(Photographed on Nov. 3, 2004)

The landslide dam in Higashi-Takezawa district was formed as a result of a landslide that occurred on the left bank slope of the Imogawa River. The size of the slide was estimated to be 350 m long, 295 m wide, and 30 m deep, and the extent of the original landslide displacement at the upper part of the slope was about 70 m. The end of the landslide mass blocked the Imogawa River and reached National Road 291 running parallel to the river on the opposite bank. The volume of sediment blocking the river course was 655,940 m³ and the maximum volume of dammed-up water was 2,560,500 m³ at its highest level.

Based on the results of a site reconnaissance, the sliding soil mass itself was judged to be stable, and only a slight possibility of collapsing from water pressure was determined to exist because the longitudinal length of the blockage was sufficiently large compared to the water depth. However, as the water level continued to rise day after day, drainage of the dammed-up water was urgently required to

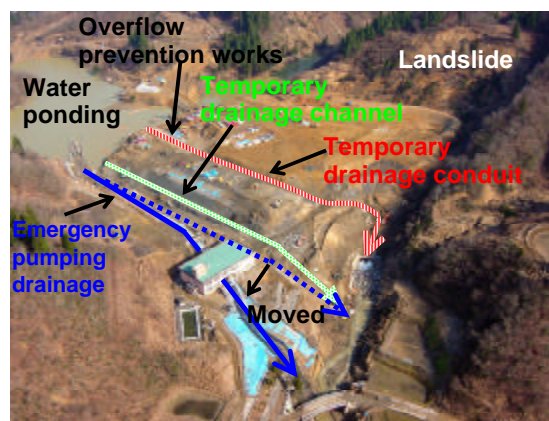
Photo 2 Emergency actions for the landslide dam in the Higashi-Takesawa dist. (Photographed on Dec. 14, 2004)

To prevent overflow, an emergency pumping drainage system was installed at the landslide dam with a pipe system length of 102 m. Twelve pumps with a maximum drainage capacity of 0.5 m³/s were installed on the upstream side and were operated 24 h a day. In addition, large sandbags (1 t/bag) were piled on the lower part of the landslide soil mass to form an earth embankment. However, the water level continued to rise and the ground around the outlet of the pumping drainage system was quickly eroded. To avoid the collapse of the landslide dam due to the progress of this erosion, it was decided to change the pumping drainage path, which initially been constructed on shortest but most erodible route. The path was changed to terminate in an erosion-resistant area outside the landslide soil mass, through the area of the former Higashi-Takezawa Elementary School (Fig. 2, Photo 2).

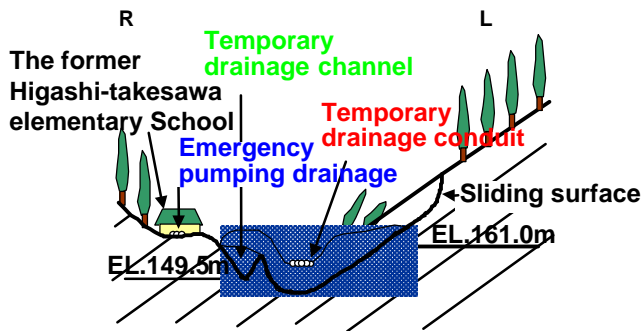
Fig. 2 Cross-section of the landslide dam in the Higashi-Takesawa dist.

To discharge snowmelt water safely, a temporary 280-m-long spillway was constructed with a maximum gradient of 22.4%. Considering the stability of the landslide during and after the construction, as well as the feasibility of completing construction before the start of the snowmelt season, the starting point of the temporary drainage channel was to be placed at 149.5 m a.s.l.

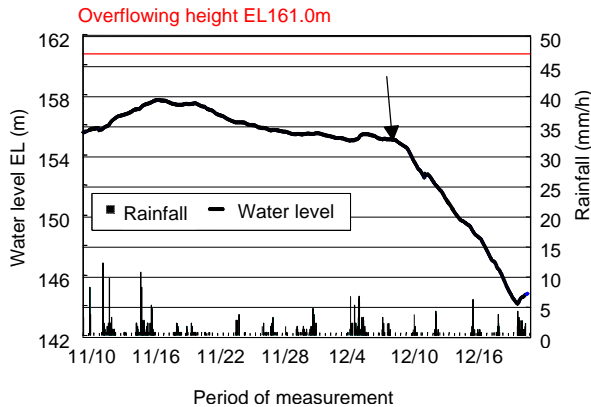
Fig. 3 Water level change at the landslide dam in the Higashi-Takesawa area. Both the water level and rainfall were measured at this location. Before the earthquake, the riverbed at this location was about 130 m a.s.l. An arrow shows the moment that the water level abruptly reduced due to a combination of emergency drainage channel and temporary drainage conduit.

was installed by placing an inlet at a point 155 m a.s.l. The conduit was made of five high-density polyethylene pipes each with a diameter of 1.0 m and a length of 250 m. This permitted the water above the inlet level at 155 m a.s.l. to flow downward at a rate of up to the full-pipe flow capacity of 10 m³/s even without pumps. This resulted in a considerable reduction of the water level (Fig. 3).

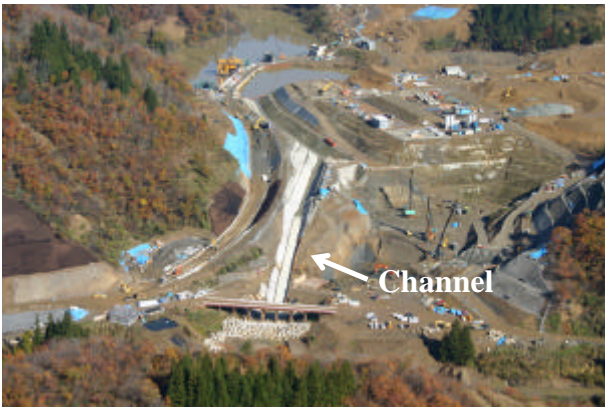
Photo 3 Landslide dam in Higashi-Takesawa area
Photographed on 2005.11.21

order of priority at earthquake-damaged locations. The locations included large-scale landslide dams like the one in Higashi-Takezawa district where emergency countermeasures were undertaken. The Sabo Office coordinated its efforts with local reconstruction plans and completed all sabo works by March 2007 (Photo 3).

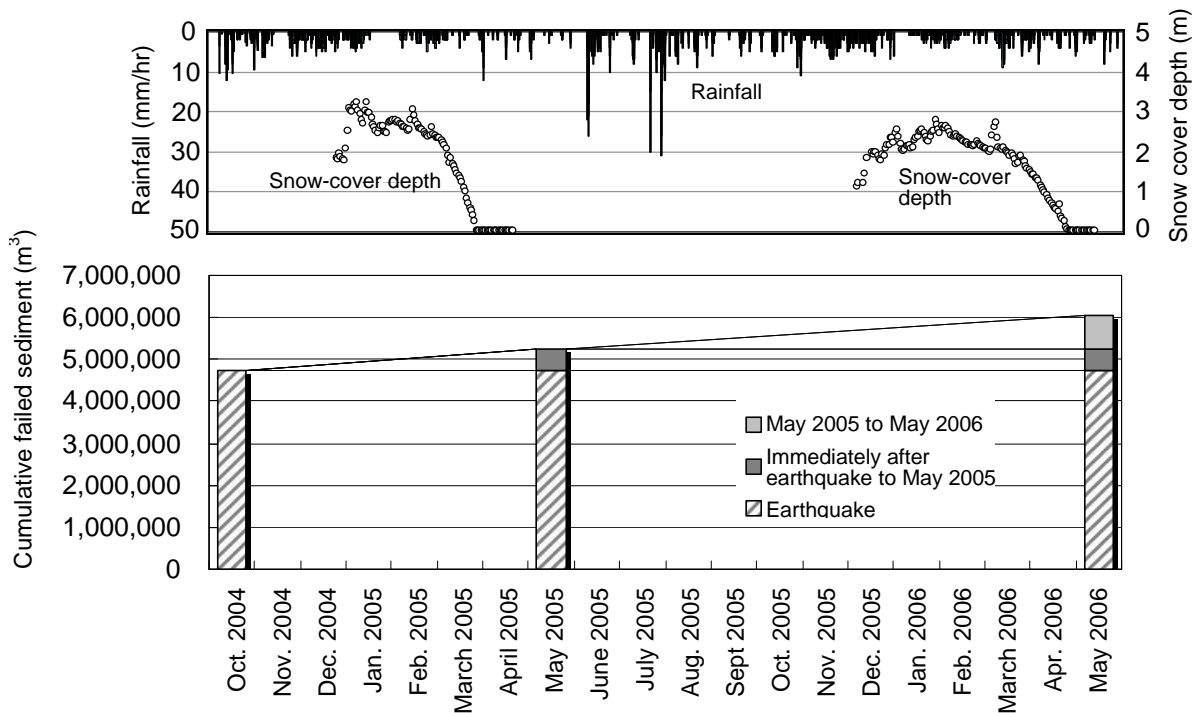
Fig. 5 Temporal change in failed sediment produced in the entire Imogawa River basin.

From immediately after the earthquake until May 2005, approximately 600,000 m³ of sediment failed (about 13% of the failed sediment at the time of the earthquake), and its cause was considered to be snowmelt. From May 2005 until May 2006, approximately 800,000 m³ of soil collapsed (about 17% of the failed soil at the time of the earthquake). This was caused by about 3,000 mm of rain and snowmelt. A comparison of the quantity of collapsed soil per unit of time shows that from immediately after the earthquake until May 2005, the amount was approximately 2,600 m³/day and from May 2005 until May 2006, this was approximately 2,200 m³/day. This indicates that in the Imogawa River basin, sediment continues to be produced by slope failures.
