Sediment Disasters Caused by Typhoon No.14, 2005, in Miyazaki Prefecture

Yoshinobu TANIGUCHI ¹

Typhoon No.14 struck Japan in September, 2005, subjecting large areas to danger for many hours. The maximum hourly rainfall was not so great, but the total rainfall for 72 hours was > 500 mm in areas which suffered considerable damage. The typhoon caused 116 debris flows, 185 slope-collapses, and 30 landslides. Concerning human and building casualties, twenty-seven people were killed in Kagoshima, Miyazaki and Yamaguchi Prefecture, and two people went missing in Oita Prefecture. Additionally, 1,178 houses were completely destroyed and 3,692 houses were partly destroyed in Japan by the typhoon. These damages were due to comparatively heavy rainfall which continued for many hours. Large scale slope-collapses occurred in particular, around Miyazaki Prefecture due to heavy continuous rainfall (862 - 1,321mm).

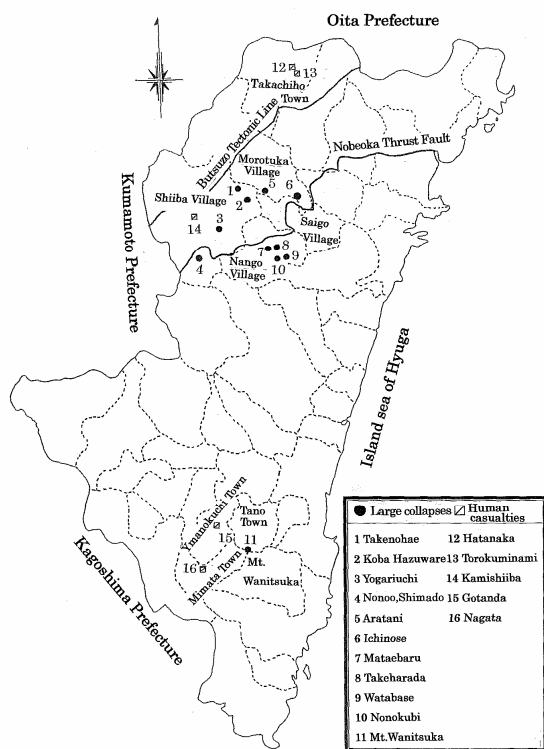
Fig. 4 Location of the immense fault and tectonic line and large slope collapses in Miyazaki Prefecture.

Wanitsuka in Tano Town during typhoon No.14 were all larger in scale compared to the ones which had occurred at Kashiba in Nangou Village in 1954, Tobinomoto in Nishimera Village in 1971, Nishiuchitate in Ebino City in 1972, and Yuzuriha in Saito City in 1982 (Miyazaki Prefecture, 2006). Except for Mt. Wanitsuka, all of these collapses occurred in or around the zone of the Butsozo Tectonic Line and Nobeoka Thrust Fault. This indicates that the collapses have a close connection with the large fault or tectonic line in addition to rainfall. The immense fault and tectonic line of Miyazaki Prefecture as well as sites of large slope-collapses caused by typhoon No.14 are shown in Fig. 4. Rainfall distribution and sites of slope-collapses during typhoon No.14 are shown in Fig. 5.

Five casualties occurred during typhoon No.14 in 2005 in Miyazaki Prefecture. One death occurred in Yamanokuchi Town, two deaths in Mimata Town, three deaths in Shiiba Village, and five deaths in Takachiho Town. A total of 11 people were killed by these disasters. Sites of these casualties are shown in Fig. 4. Characteristics of these casualties are as follows: distances between the points of collapses and the stricken homes were very short, evacuation was not sufficient, most of victims were elderly (64.4 years old on average), scales of all slope-collapses were small, and calamities occurred at dawn or noon.
